Manhole Inspection Summary

Manhole # S13Q__005MH

Insp Date: **3/18/08 2:03 PM**

Location Address: **Dukeland St**

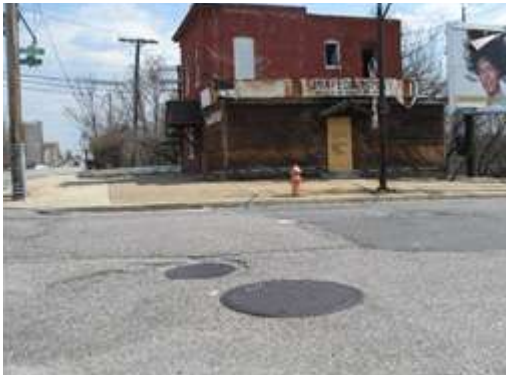
Location View

Comments **MH located at intersection of Dukeland and Wilkins...Map indicates three pipes where there are only two.**

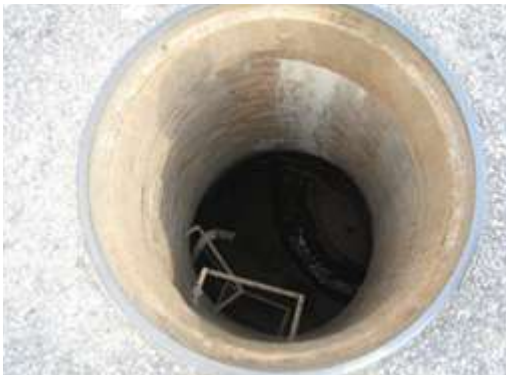
misc

additional top view

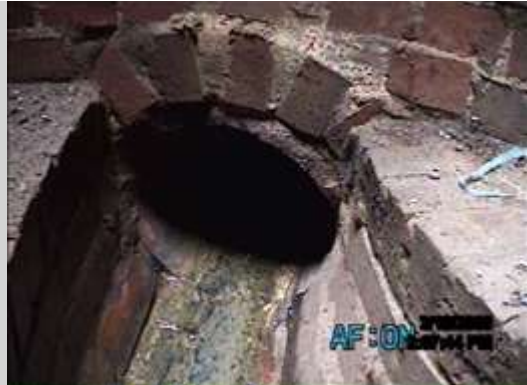
12 O'Clock Outflow

10 in. Circular Gravity Sewer
Pipe Out @ 12 O'Clock

Pipe Height: **10.8** (in.) Rod and Bar (Angled)
Pipe Material: **Clay** ☐ Pipe Lined
Invert Depth: **9.92** (ft.) Flow Characteristics: **Slow**
Deposits: ☒ None ☐ Mud ☐ Sludge ☐ Debris ☐ Grease
Silt Depth: **0** (in.) Deposits Extent:
Infiltration: **None** Pipe Seal Cond: **Sound**
